**Image Diagnostics, Inc.**

## ***Aspect 100-4T G3 and ISR G3***

### **Mobile Image Tables**

## ***Unpacking Instructions***

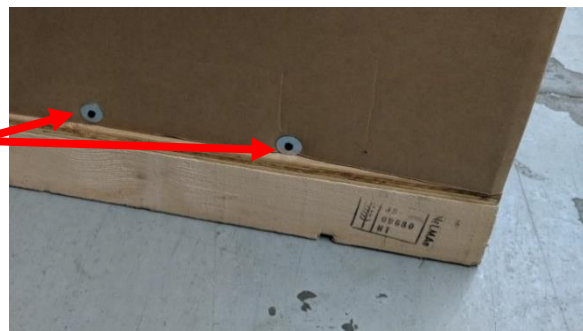
2. With the Tilt-Skid on a hard, smooth, and level surface; use a Phillips #2 screw driver or drill/driver to remove all black screws around the base of the cardboard carton as shown in the picture to the right. Lift the Carton straight up and off the Tilt-Skid over the Table.
